# ONBOARD SYSTEMS

## SERVICE LETTER

No. 51  
Nov. 15, 1996

SUBJECT: Drain Holes

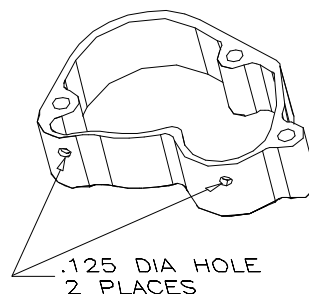
It is possible for the area of the hook that encloses the manual release mechanism to become partially filled with water when washing the aircraft or from driving rain. The water enters around the hole for the manual release lever. The water can lay in the bottom of the chamber and later freeze. The ice could jam the manual release cable and mechanism. To prevent this from occurring we have added drain holes to the P/N 290-299-00 cover on production units from S/N 029 and on. For serial numbers 028 and lower we are recommending that two .125 dia. holes be drilled in the P/N 290-299-00 cover. Touch up the holes with Alodine after drilling.

We would be happy to do this modification for you or send you a new cover at no charge if you prefer. Please give me a call and we can arrange a plan that is most convenient for you.
