ONBOARD SYSTEMS

SERVICE LETTER

No. 51
Nov. 15, 1996

SUBJECT: Drain Holes

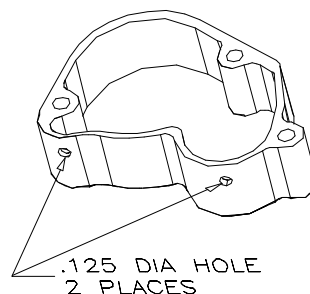
It is possible for the area of the hook that encloses the manual release mechanism to become partially filled with water when washing the aircraft or from driving rain. The water enters around the hole for the manual release lever. The water can lay in the bottom of the chamber and later freeze. The ice could jam the manual release cable and mechanism. To prevent this from occurring we have added drain holes to the P/N 290-299-00 cover on production units from S/N 029 and on. For serial numbers 028 and lower we are recommending that two .125 dia. holes be drilled in the P/N 290-299-00 cover. Touch up the holes with Alodine after drilling.

We would be happy to do this modification for you or send you a new cover at no charge if you prefer. Please give me a call and we can arrange a plan that is most convenient for you.
