SERVICE BULLETIN

Document No. 159-012-00, Rev. 0 November 10, 2003

ONBOARD SYSTEMS INTERNATIONAL

Subject: Cargo Hook enhanced safety.

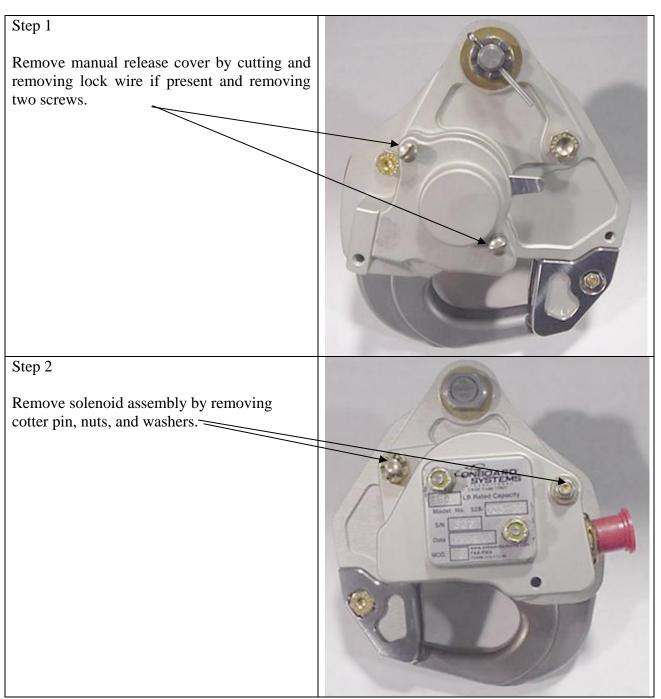
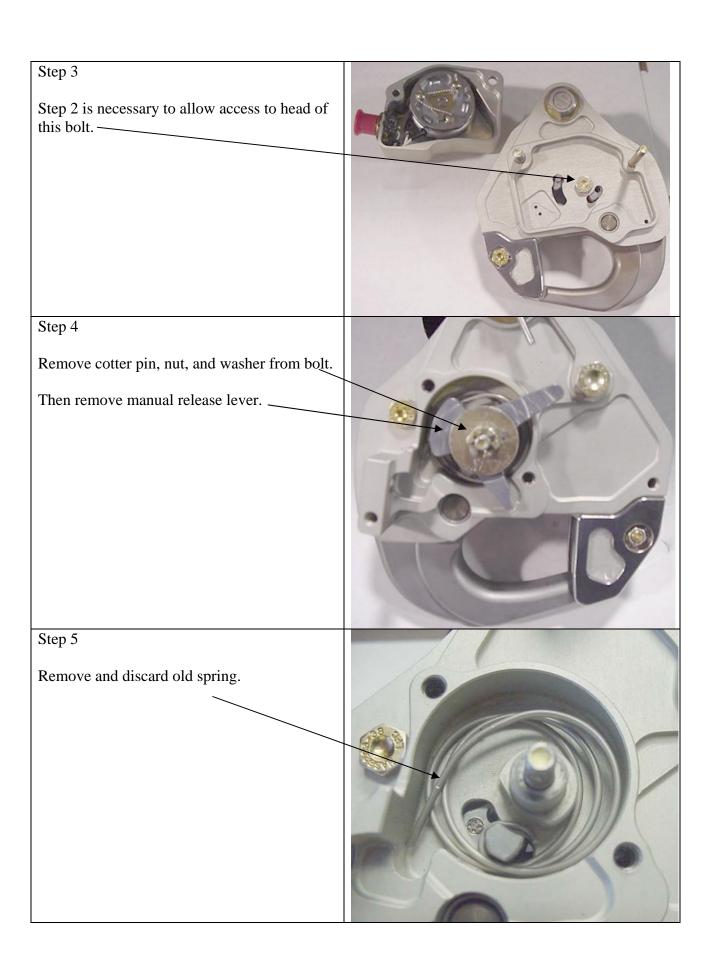
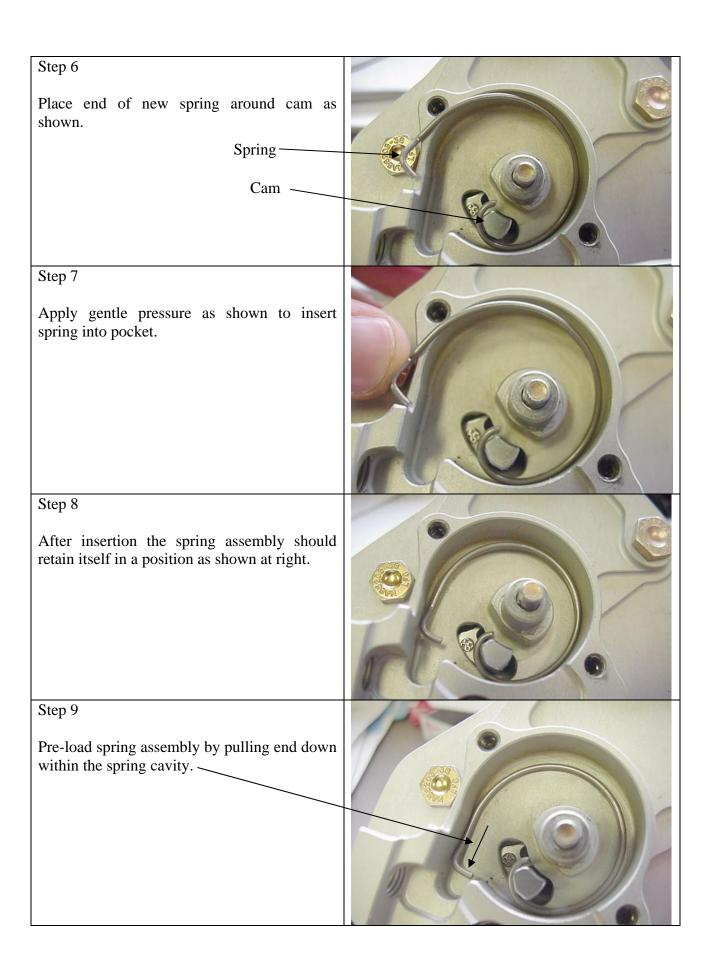
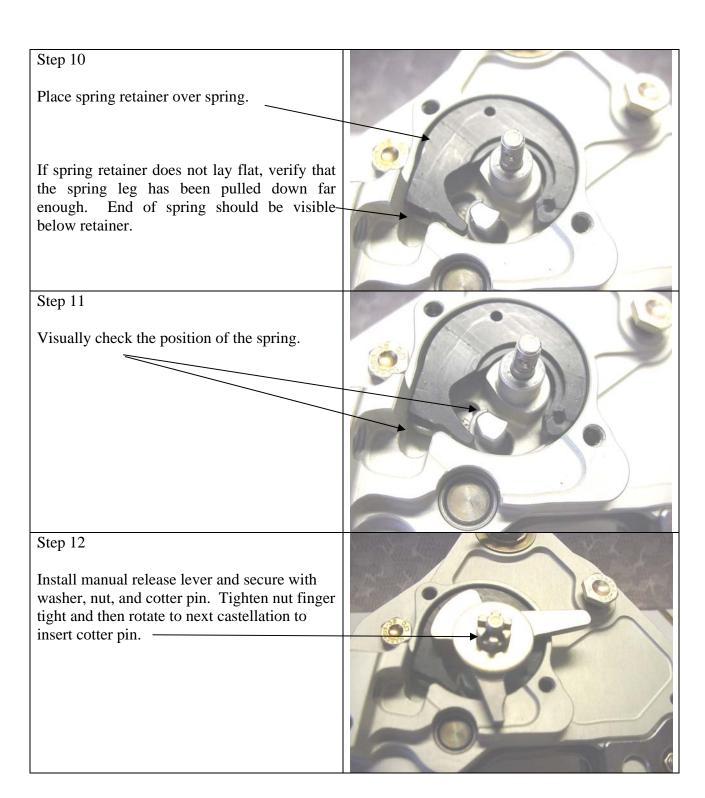
The cargo hook, based on reports from the field, has exhibited inconsistent relatching of its internal release mechanism. The problems have been traced to an internal spring, which is used to retract the release mechanism and manual release cable after a load is released. Upon further investigation it has been concluded that due to manufacturing inconsistencies some of the springs do not provide an adequate retract force or have a tendency to work their way out of their optimal operating position. In the event of this occurrence, the result may be an incomplete locking of the mechanism. This could lead to an inadvertent load release.

This service bulletin contains instructions for replacing the existing spring with a new spring and spring retainer. The new spring is of a design that provides a higher retract force. The spring retainer ensures that the spring is maintained in its proper position.

Remove existing spring and replace with spring and retainer per included instructions beginning at step one.
