Subject: Service Bulletin 159-036-00, Rev. 0 for Load Cell Torsional Fatigue Failure

Document: 159-036-00

Revision: 0 Date: 6/22/2015

Subject: Load Cell Torsional Fatigue Failure

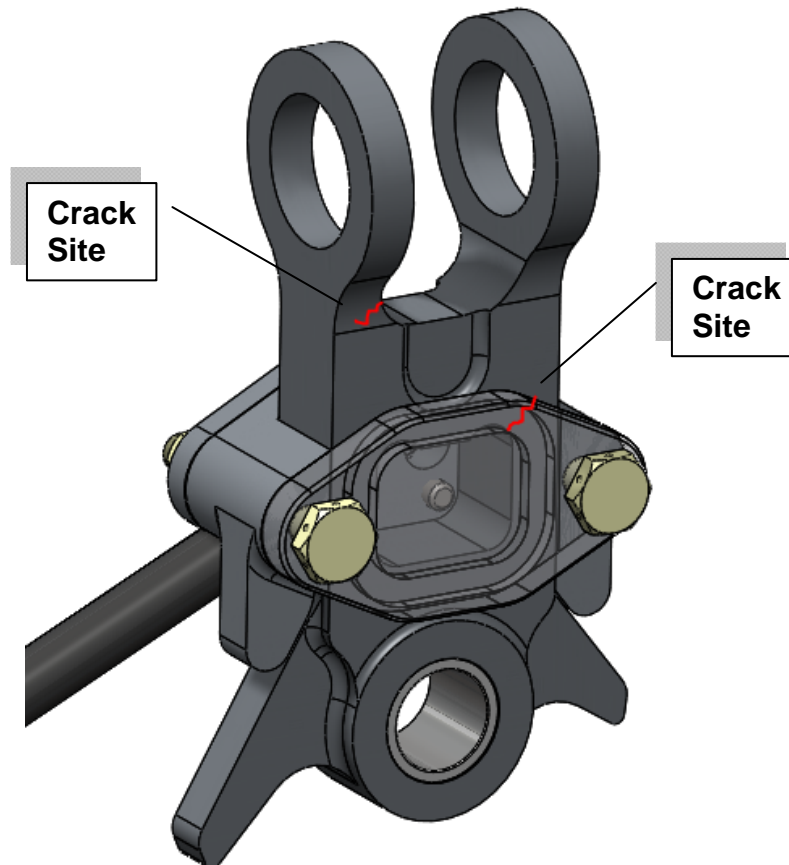
Description: A small number of load cells have been reported to have structurally failed in the field, leading to loss of load. In each instance, investigation has suggested that these failures occurred as a result of repetitive torsional loading, as defined herein. Certain types of external cargo configurations place torsional loads on the cargo hook attachment, including the load cell. Over time, fatigue failure may result.

Figure 1 – Crack initiation site of load cell due to torque loads (210-249-XX). Note: cracks may begin under cover plates and not be observable without disassembly.

Solution: Several Onboard Systems load cells have been redesigned to better accommodate torsional loads. If torsional loading is a part of your helicopter operations (as defined herein), it is recommended that that you upgrade to the latest configuration as expeditiously as possible. If torsional loading is *not* part of your helicopter operations, it is recommended to upgrade at time of next overhaul.

- (2) If torsional loading is present per the **Torsional Load Description** definition on page 3, limit external load time to 100 hours between overhaul of the load cell. Upgrade the load cell to the latest configuration as soon as possible. Remove and replace the load cell per the applicable Instructions for Continued Airworthiness manual. Time between overhaul then returns to the period defined in the applicable documentation (see Publications Affected).

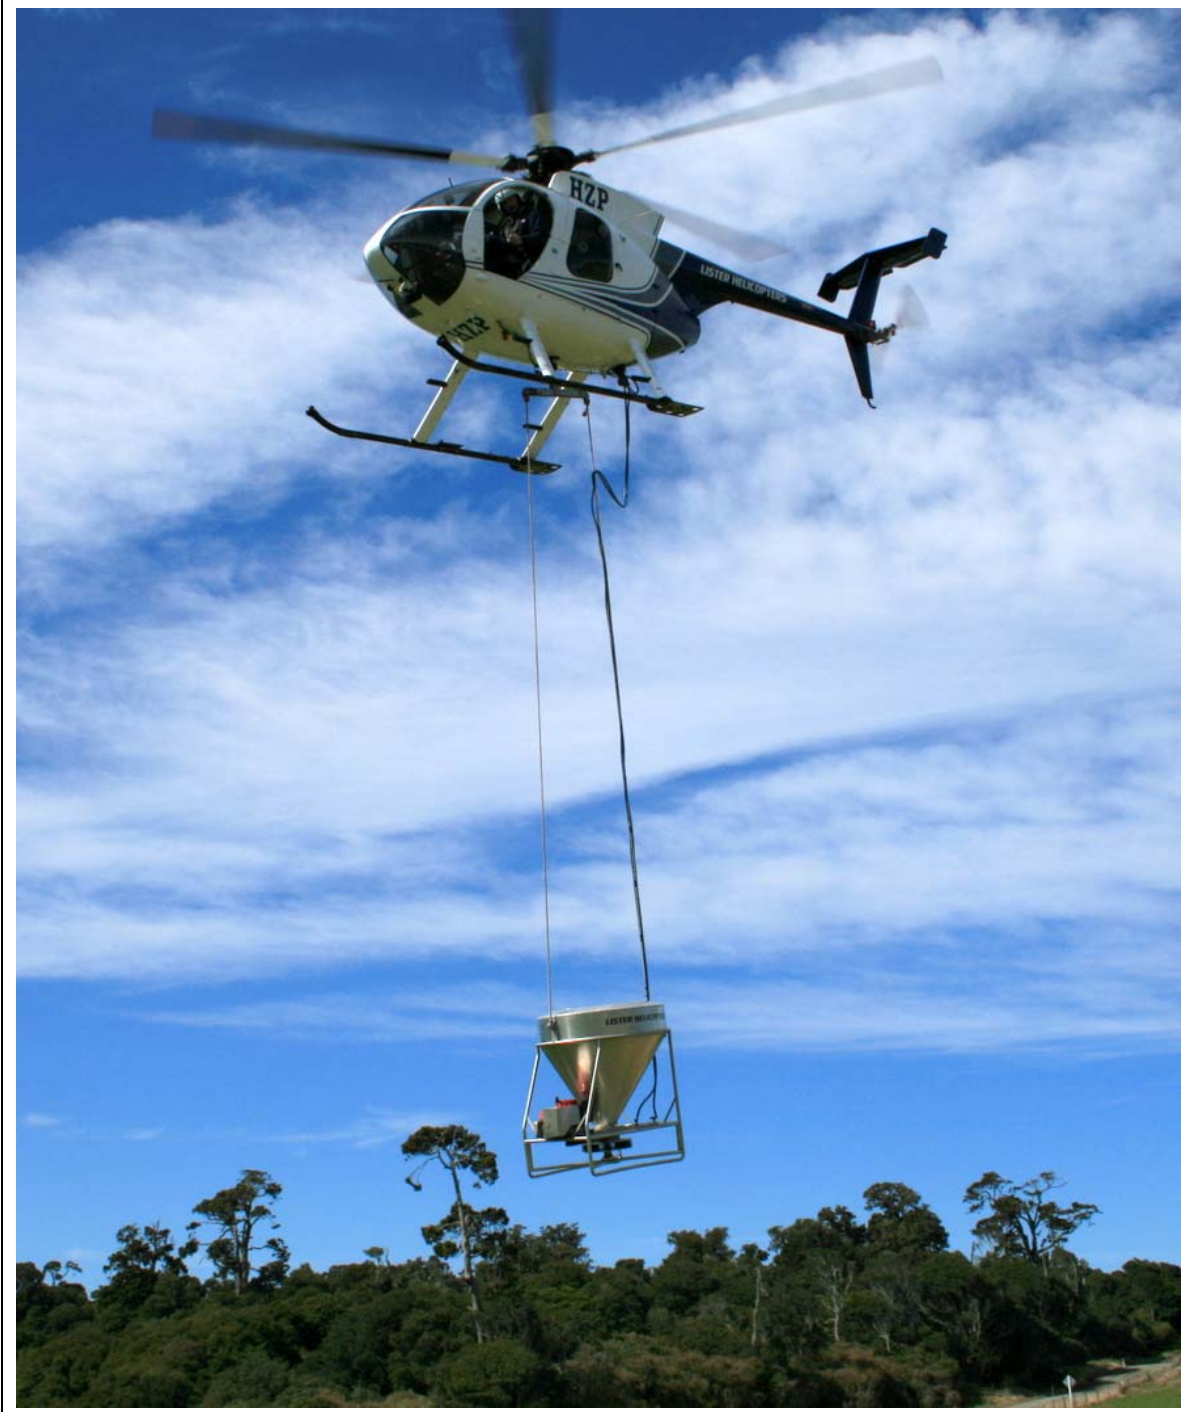
- A load is attached to the cargo hook with a spreader bar, e.g., typical fertilizer slinger.
- A load is rigidly attached to the cargo hook, e.g., an aerial saw

Figure 2 – Fertilizer application using bucket and spreader bar. Photo: Lister Helicopters
