Subject: Service Bulletin 159-054-00, Rev. 0 for Swing Suspension Load Cell / Gimbal Inspection

Affected Aircraft: Airbus AS350 and AS355

SERVICE BULLETIN

Subject: Swing Suspension Load Cell / Gimbal Inspection

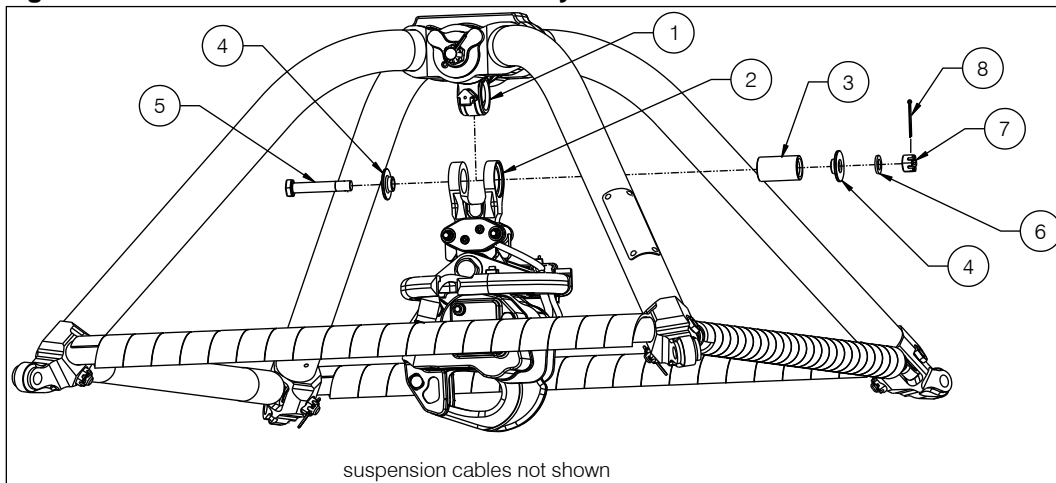
Figure 1 Load Cell/Gimbal Joint Disassembly

Remove from aircraft, disassemble and inspect the upper joint of the Load Cell per the following, referring to Figure 1 for item numbers in parentheses (). For part numbers of these items, refer to Table 3.

1. Disconnect the electrical connections, ground strap and mechanical release connections at the aircraft.
2. Remove the Swing Frame Assembly from the helicopter by removing the four quick release pins at the shackles on the aircraft hard points.
3. Remove the cotter pin (8), nut (7), washer (6), Retaining Bushing (4) from the end of the bolt (5).

4. Remove the bolt and Retaining Bushing (4) under its head and slide the Gimbal Shaft (3) out from the Gimbal (1) and Load Cell (2) while supporting the cargo hook.

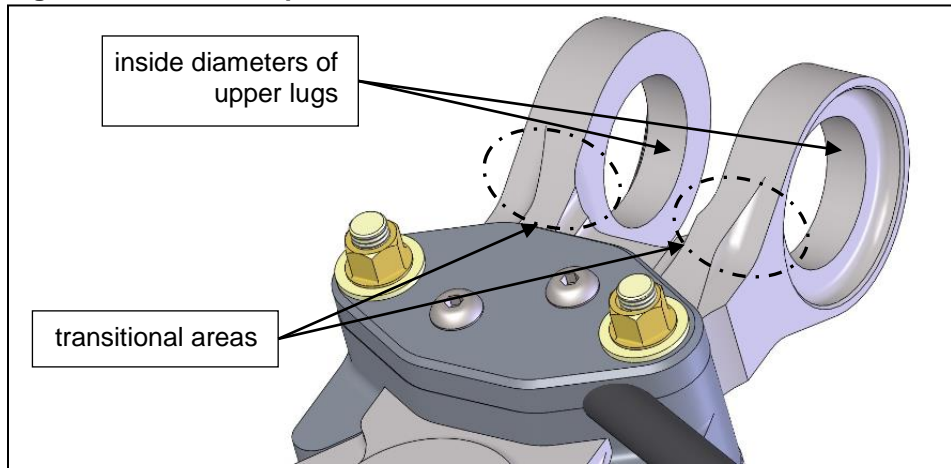
Figure 2 Load Cell Inspection

6. Inspect the inside diameters of the upper lugs of the Load Cell (reference Figure 2) for signs of wear such as pitting, galling, or elongation of the holes. If the inside diameter of the lugs exceeds .759 in. (19.3 mm), the load cell must be replaced. There should be no visible wear, aside from light burnishing of the inside diameter surfaces. If the burnishing can be removed using the Scotch Brite, it is considered light.

Visually inspect for cracks around both lugs, including the transitional areas (reference Figure 2) where the lugs transition into the flat portion of the Load Cell. Inspect these areas on both sides.

7. If the Load Cell requires replacement, refer to the applicable ICA manual as referenced in Table 2.
8. Inspect the flanged DU bearings of the Gimbal (1) that interface with the Gimbal Shaft. As these bearings wear, the low-friction PTFE layer is removed, exposing the copper layer below. Across the width of the bearing surface, no more than 50% should be the exposed copper layer (reference Figure 3).
