SERVICE BULLETIN

Subject: Airbus Common Beam Master Cylinder Leakage

Helicopters Affected: EC135 / EC145 aircraft with Common Beam Cargo Hook System

Document: 159-048-00

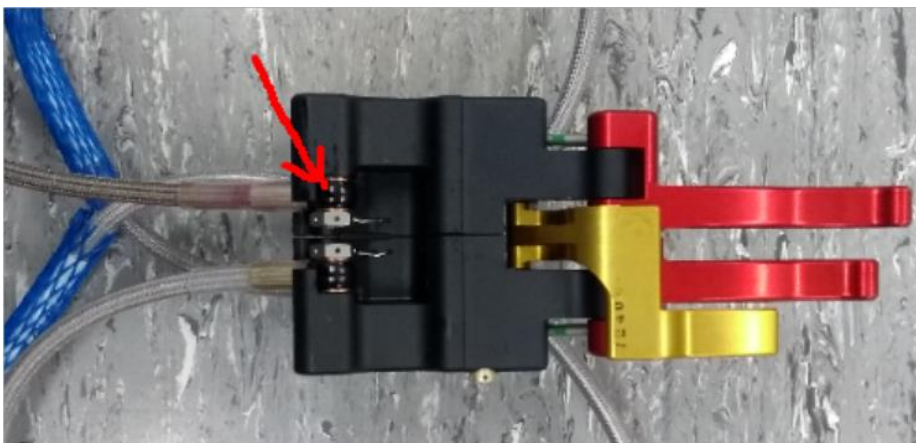
Figure 1 – Master Cylinder fluid leakage location

Description of Incident: Onboard Systems has been notified by Airbus Helicopters of multiple instances of hydraulic fluid leakage from 'Common Beam' Master Cylinder assemblies at the connection point between the hydraulic hose and Master Cylinder reservoir. Evidence of hydraulic fluid can be seen as wetness on the Banjo Bolt and pink-colored discoloration under the hydraulic hose protective sleeving.

Recommended Action: Inspect affected Master Cylinders for leaking condition described above. If no leakage is found, no further action is necessary. If leakage is found, this Service Bulletin outlines two acceptable means to eliminate the leakage:

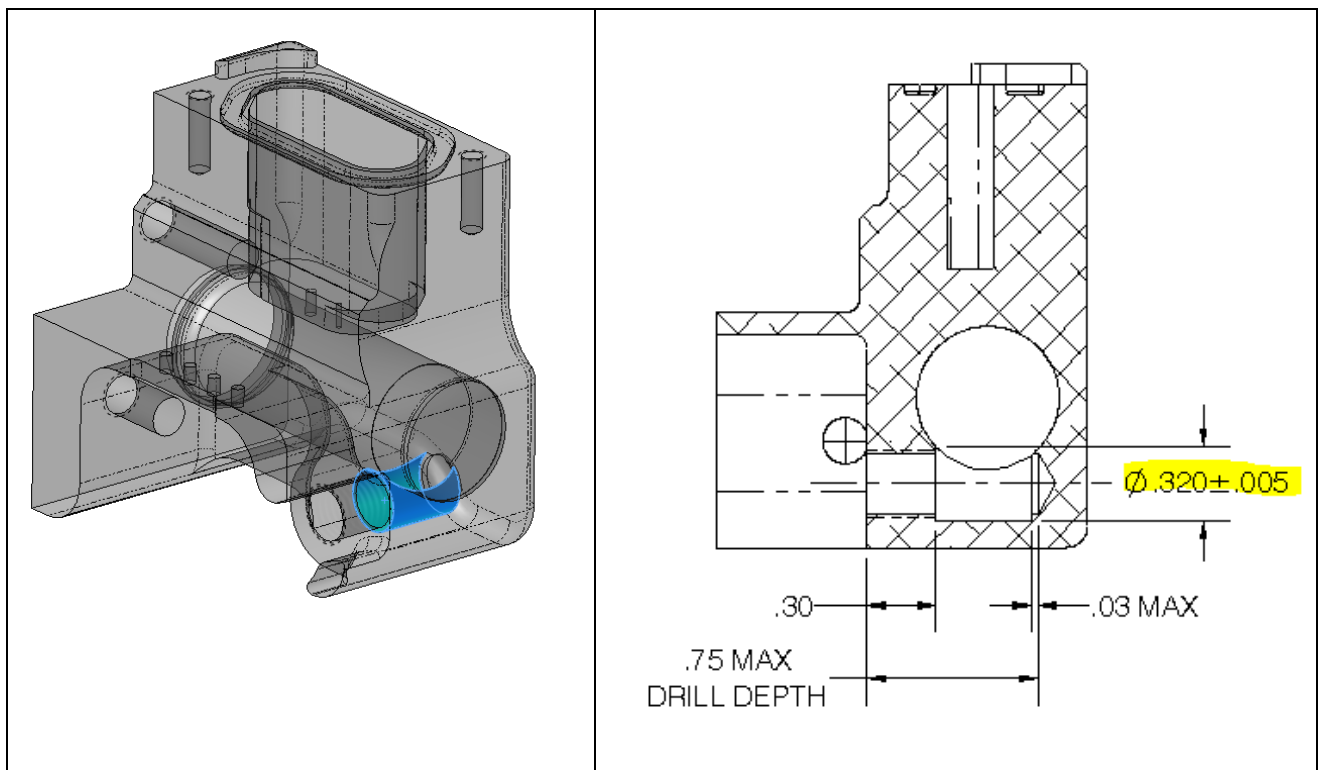
Figure 2 – Missing thread relief

Findings indicate the primary root cause of the leakage to be a production nonconformance within both Master Cylinders (P/Ns 291-836-00 and 291-837-00). Inventory inspected showed that a thread relief was missing from physical parts: Ø.320 feature highlighted in Figure 2.

This missing feature can cause unintended interference between the Banjo Bolt (P/N 291-665-00) and Master Cylinder—preventing full clamping force of the sealing joint, even after full assembly torque. The cause of this is that the Banjo Bolt potentially bottoms out against a blind thread of limited depth. See Figures 2 & 3.

Onboard Systems will fully disassemble the Master Cylinder, add the missing thread relief depicted in Figure 2, reassemble (increasing the assembly torque of the Banjo Bolt) and re-ATP. As CNC machining is required, this process is not feasible to conduct in the field.
