**ONBOARD SYSTEMS
INTERNATIONAL**

Alert Service Letter
Document No. 159-025-00 Rev. 0
Date: May 5, 2009

Subject: Verification of proper hook locked indication before performing external load operations with cargo hook P/N 528-029-00 or -01

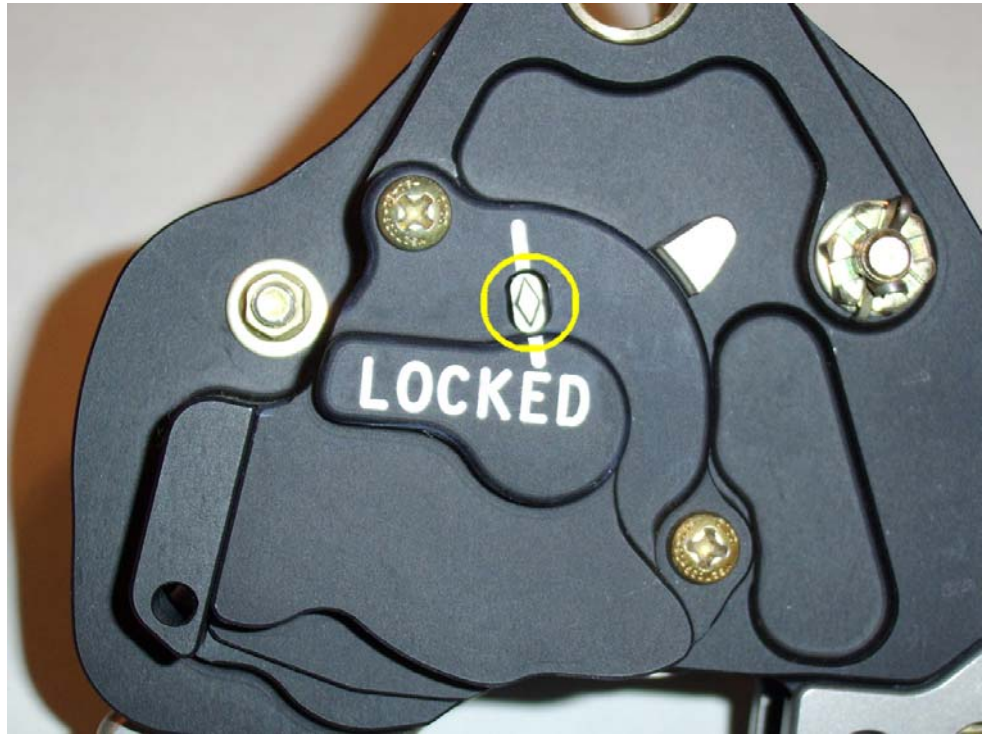
FIGURE 1

Onboard Systems would like to stress the importance of following the proper guidelines for verifying that the cargo hook P/N 528-029-00 or -01 is locked before performing any external load work. This is accomplished by verifying that the hook lock indicator on the side of the hook returns to the fully locked position every time the hook is latched. In the fully locked position, the top and bottom corners of the diamond shape on the hook locked indicator should align with the lines on the manual release cover (see Figure 1).

Picture of a cargo hook that is in the fully locked position. Note that the top and bottom corners of diamond shape showing through the opening of the lock indicator window (circled in yellow) are lined up with the white lines on the hook.

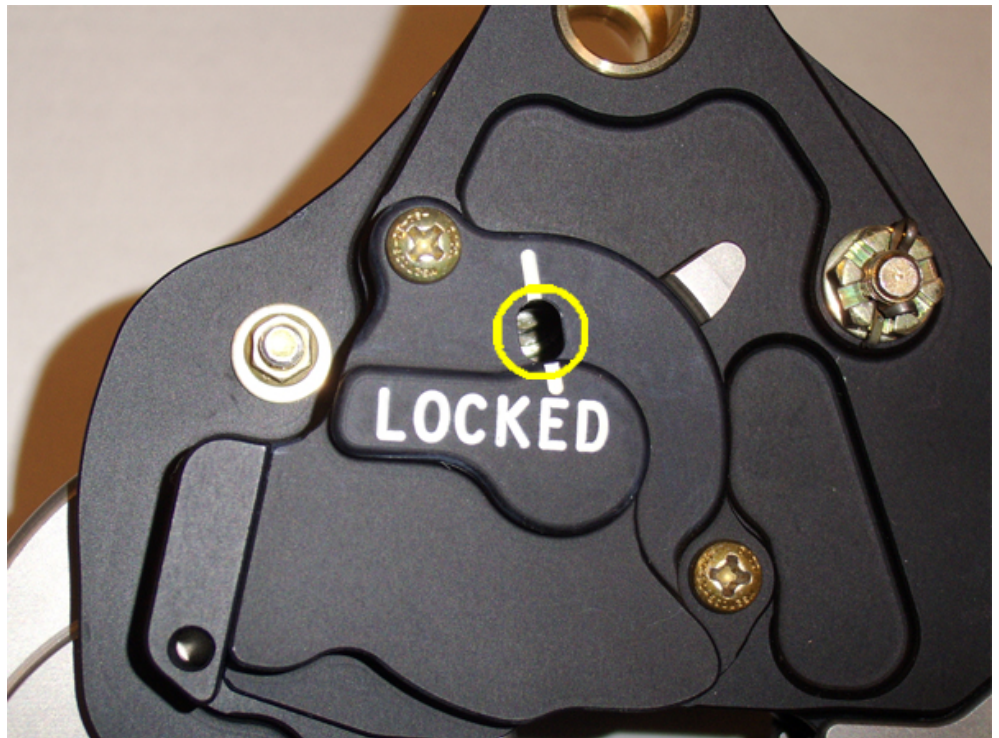
FIGURE 2

Picture of a cargo hook that is in the open position. Note that the locked indicator window (circled in yellow) is empty. This hook is not fully locked.

If the hook does not re-latch properly (see Figure 2 and 3), it is critical that you do not use the hook until the problem is resolved, as an inadvertent load loss could result. Some possible causes for not re-latching properly include incorrect rigging and routing of the manual release cable, a cable that is worn, binds or sticks and prevents the hook mechanism from locking, incorrect cable part number or release fitting installed or lack of proper maintenance. In addition, the load beam may close and feel secure, but the mechanism is not in a stable locked position unless the lock indicator returns to the fully locked position.

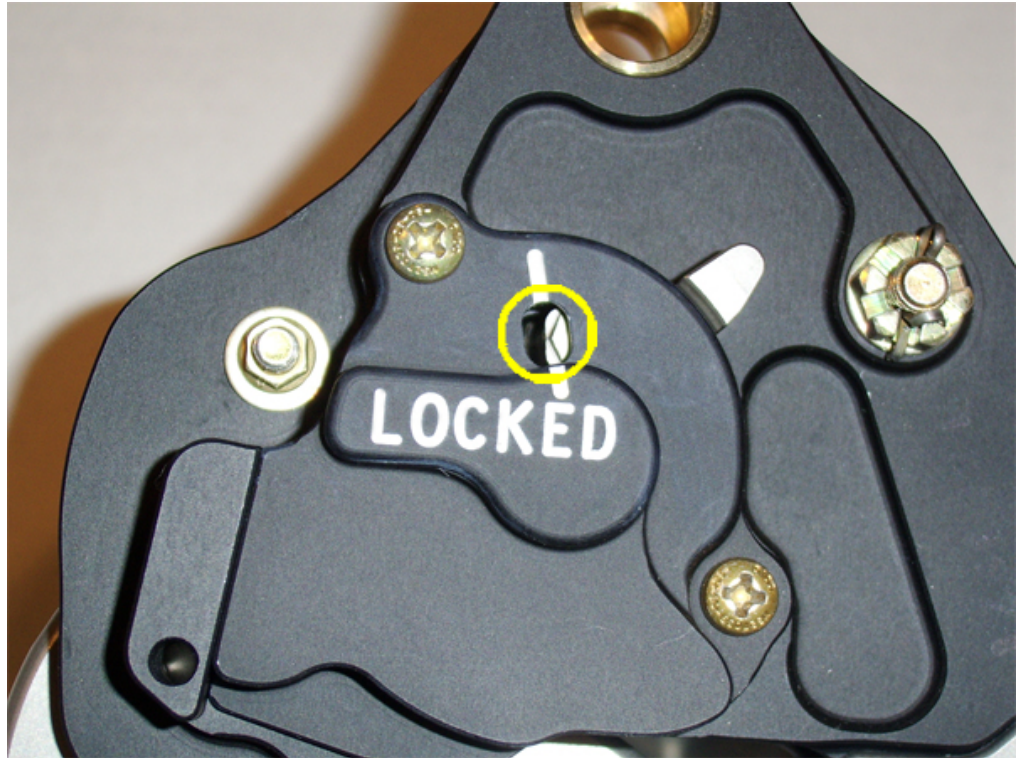
FIGURE 3

Picture of a cargo hook that is not fully re-latched. Note that while the edge of the metal indicator is lined up with the white lines on the hook, the top and bottom corners of diamond shape showing through the opening of the lock indicator window (circled in yellow) are not. This hook is not fully locked.
